Characterization of Surface and Sub-Surface Defects in Optical Materials Using the Near Field Evanescent Wave

M. Yan, S. Oberhelman, L. Wang, W. Siekhaus and M. Kozlowski

This paper was prepared for submittal to 5th International Conference on Near Field Optics and Related Theoriques (NFO-5) Shirahama, Japan December 6-10, 1998

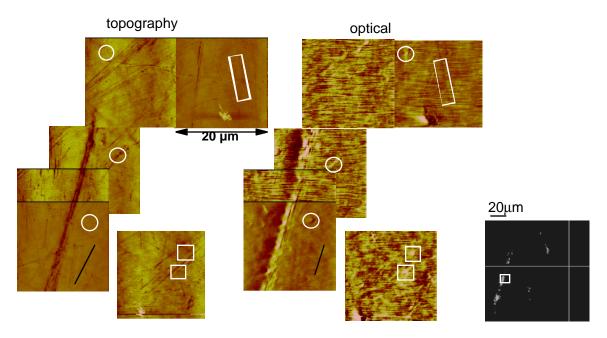
Figure 1. Topographic NSOM images (left) and optical evanescent wave NSOM images (middle) of a large area (each image is $20\mu m$ square) of a polished fused silica surface. The image at the right (shown for comparison) is a conventional total internal reflection image.

In this paper, we characterize surface and sub-surface defects in fused silica and optical coatings using the surface evanescent wave measured by NSOM implemented on a large-stage AFM. A laser irradiates the sample surface in a total internal reflection configuration. The evanescent wave from the surface is collected by an apertured fiber probe of the NSOM. The amplitude of the surface evanescent wave is proportional to the laser intensity at the surface and therefore sensitive to surface as well as sub-surface defects located in the near-field range (~ 100nm). This subsurface region is thought to contain the great majority of polishing-induced defects. The apertured near field fiber probe provides a spatial resolution of ~100nm and the large stage AFM makes it possible to locate defects in samples with diameters up to 6". We are thus able to map out surface-as well as near-surface optical defects in a large optic, as shown in figure 1, as a first step in understanding laser damage mechanisms. These observed defects will be exposed in situ to high fluence laser light to correlate with the initiation of laser damage. We have also used NSOM to measure in situ the effect of chemical etching on optical properties of
